Durability of Galvanized Steel Framing in Residential Buildings

Summary of a ten year report produced by NAHB Research Center, a subsidiary of the National Association of Home Builders (NAHB) in the US and sponsored by International Zinc Association

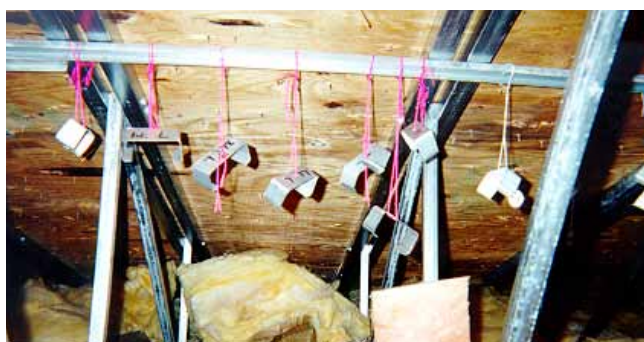
Figure 3 - Attic Specimens in Miami, Florida Site

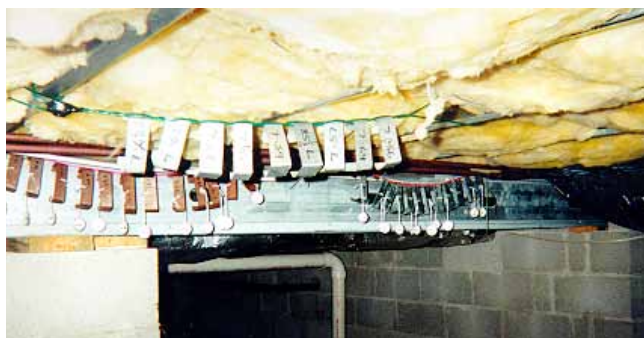
Specimens were installed in the attic, an exterior wall, the crawl space, and under the outdoor deck. The crawlspace contained a set of suspended samples fully exposed to the ambient crawlspace environment, including bare (stripped) stud-type specimens. The bare samples displayed extensive corrosion after just two months of exposure, indicating the aggressive environment in the crawlspace (see Figure 5). Specimens were also installed under an outdoor deck, which represented

Figure 5 - Stud specimens in Leonardtown Site crawlspace. Note the uncoated C-sections in the background show red rust after just two months of exposure.

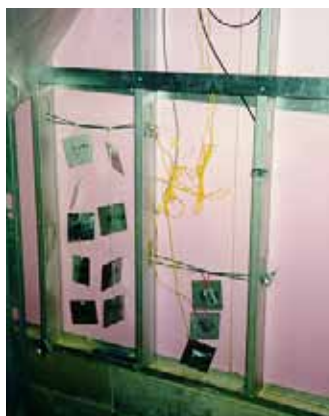
Figure 7 - Wall Cavity Specimens and Sensors in Hamilton, Ontario, Site
