Durability of Galvanized Steel Framing in Residential Buildings

Summary of a ten year report produced by NAHB Research Center, a subsidiary of the National Association of Home Builders (NAHB) in the US and sponsored by International Zinc Association

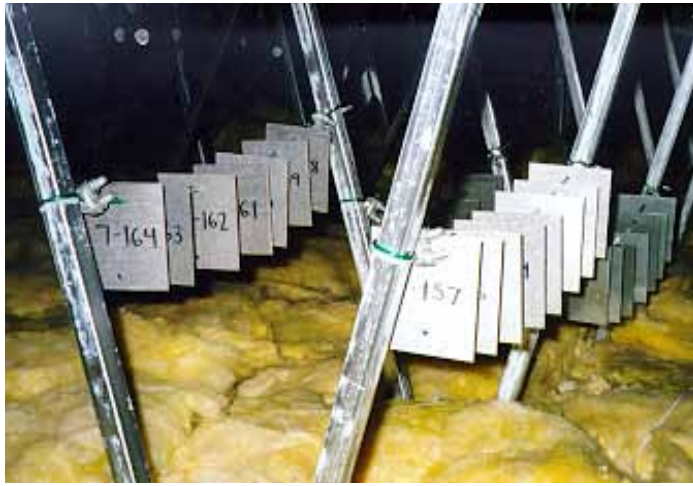
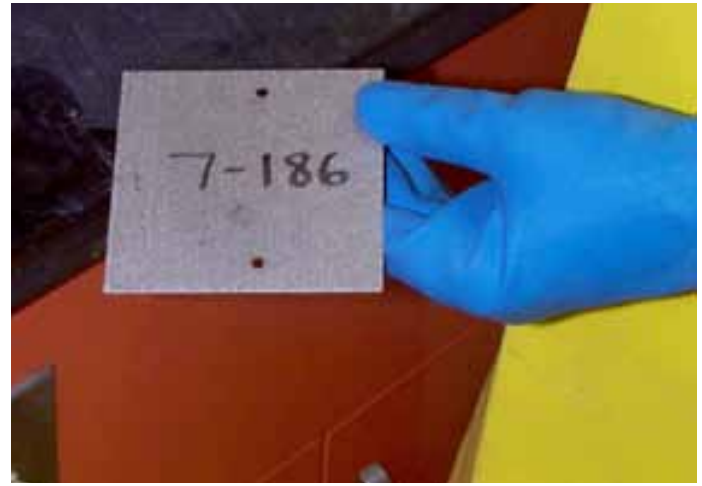
Figure 1 – Plate Samples

of the specimen's area, and thus a more accurate measure of coating corrosion rates calculated from mass reduction of the samples after exposure (Figure 1). The C-section samples were installed to investigate corrosion performance at the edges and bends of a stud. Both the plate and stud samples had both sides and all edges exposed. The coating thickness specifications and measured coating weights of the samples are listed in Table 2. Coating Thickness (column 5) is the calculated coating thickness based on the measured coating mass in column 4. Coating tests performed per ASTM A90/A90M¹ determined that actual coating masses (column 4) were all above the minimum specification requirements. Samples were installed to allow for analysis after one, three, five, seven, and ten years of exposure. An overview of where samples were installed in the four sites is provided in Table 3.

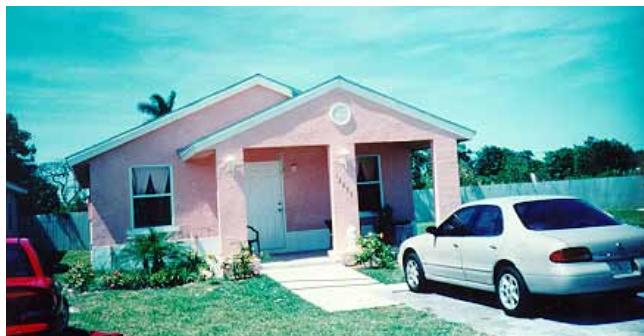
Figure 2 - Miami, Florida Corrosion Site

The Miami site (Figure 2) was in a Habitat for Humanity Development in southwest Miami, where 16 of the 90 homes were framed with steel systems. The site was a single-story steel framed structure with a slab on grade foundation. It had plywood sheathing with a stucco exterior finish. The wall interior was 5/8 in. (16 mm) painted drywall. The attic was kraft faced (facing the drywall) R-30 fiberglass batt insulation, while the walls have either R-11 or R-13 batts. The walls were 6 in. (152 mm) wide. The attic was vented with soffit vents [19 vents total, each is 22 in. x 4 in. (56 cm x 20.5 cm)]. No ridge vents were present, and one small gable end vent was visible in the front of the house.

The house was air-conditioned and the type of environment could be classified as humid/inland. Although the site was in southern Florida it was several miles from any large water body. There was no shading of the house on the western exposure, where the wall cavity colonies were located.

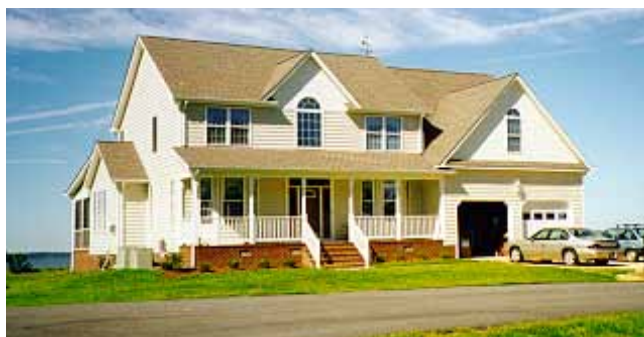
Figure 4 - Leonardtown, Maryland, Site on lower Potomac River

The Leonardtown, Maryland, house (Figure 4) was on the lower Potomac River before it empties into the Chesapeake Bay. The two-story home was roughly 75 feet (23 m) from the river, with strong winds often blowing spray towards the house from the brackish river water. The walls were framed with 0.043 in. (1.1 mm) thick steel C-section studs, while steel trusses were used for the roof framing. Steel floor joists were used in the crawlspace along with R-19 fiberglass batts. A layer of poly was installed on the crawlspace floor. The attic was insulated with 11 in. (28 cm) of blown cellulose and vented with a ridge vent and soffit vents. The walls consisted of 5/8 in. (16 mm) drywall, wet-blown cellulose (R-13), OSB sheathing, 1 in. (25 mm) of non-foil faced foam cladding (R-5), an air infiltration barrier, and vinyl siding. All bathrooms were vented directly to the outside. The foundation was vented with perimeter vents in the block wall.

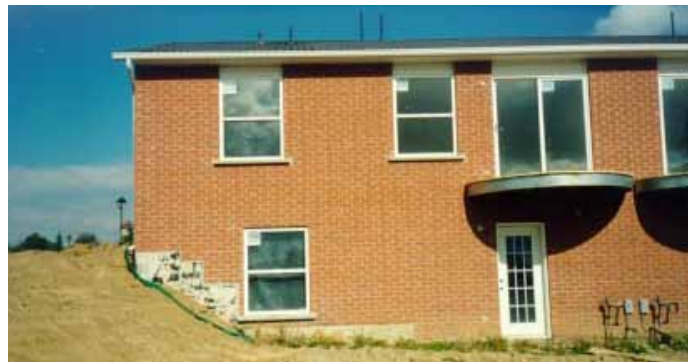
Figure 6 - Hamilton, Ontario Test Site (Rear View)

The Hamilton, Ontario, house (Figures 6 and 7) was a 2-storey townhouse block built on a concrete floor slab in a retirement community. It was the end unit, with a walkout on the ground floor. Three of the four walls were concrete block, with the fourth wall (east facing) being steel-framed. The framed walls were designed as follows: interior wall covering was 5/8 in. (15 mm) drywall, behind which a poly vapor barrier was installed. The walls were insulated with R-13 fiberglass batts. Beyond the framing was 1-1/4 in. (32 mm) of foam sheathing (R-7). Outside of the foam sheathing was a 1 in. (25.4 mm) air gap, with a brick veneer finish beyond this.

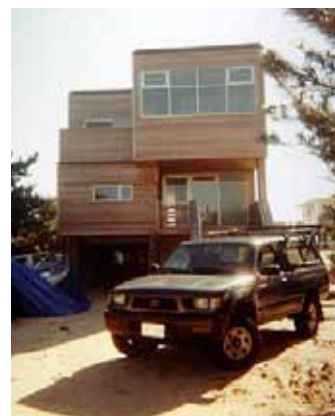
Figure 8 - New Jersey Site

The Long Beach Island, New Jersey site (Figure 8) was the last addition to the research study with specimens being installed in 1998. The site was a beachfront house on the New Jersey shore, and was separated from the ocean by a low-lying dune roughly 1/4 mile (400 m) wide. The house was originally a one-story structure, and was remodeled to include a new second floor and roof that were both framed with cold-formed steel (Figure 9). The house was occupied primarily during the summer season, and was left vacant during the winter.
